## Stabilised floor enables pre-war building to be re-used

### Introduction

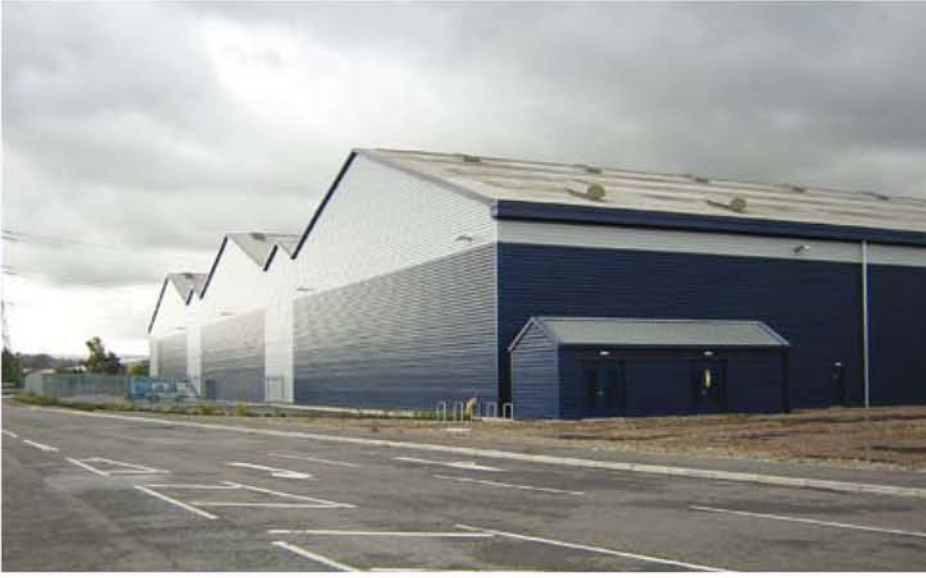
*The refurbished building ready for use as warehouse/distribution centre*
